CHARACTERIZATION OF GROUNDWATER DISCHARGE TO HAMPTON HARBOR

A Final Report to

The New Hampshire Estuaries Project

August 26, 2003

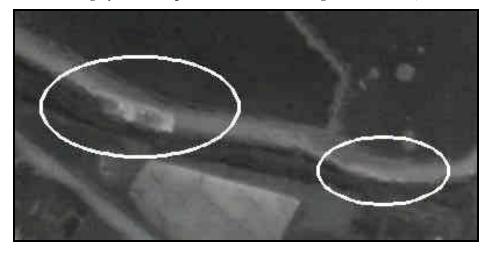
Figure 1: Thermal Imagery of a Multiple Groundwater Discharge Zones From 4,000 Feet

Methodology: Characterization of groundwater was performed by use of thermal infrared imagery coupled with field verification. The technology of thermal infrared imaging is useful in any location where there is a measurable contrast in the temperature of groundwater, receiving waters, and surrounding landforms. A thermal infrared aerial survey performed at altitude can effectively resolve up to 0.08 °C temperature differences, thereby delineating the thermal signature of groundwater discharge. TIR only measures surface temperatures so its application is limited to the intertidal zone and above, with some exceptions. Figure 1 illustrates multiple suspected groundwater discharge zones that combined are likely greater than 100,000 gallons per day. Field-verification of this site revealed a large saltwater discharge zone, and thus is not included in loading calculations. Salinity is always verified when examining groundwater discharge zones to distinguish between saltwater intrusion and freshwater discharge. This is needed for calculating loading to distinguish between ocean-derived nutrients and land-derived nutrients.
